September 12, 2018

BRYN ATHYN CHURCH SCHOOL

Facilities Planning Report
Existing Building and Space Needs Analysis

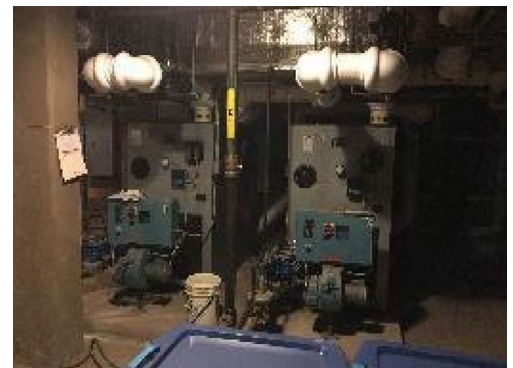
Society Bldg Boilers

Boilers – all of newer construction and appear in good condition.

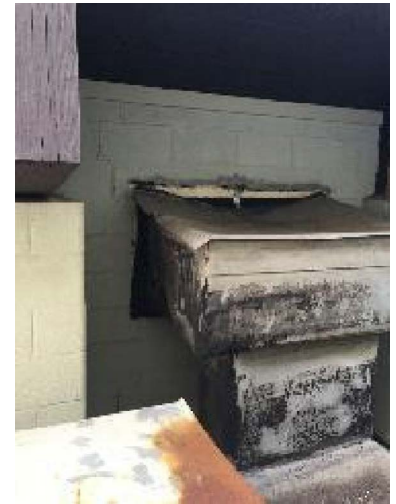
The exterior rooftop ductwork is in poor condition and requires replacement.

Society Bldg Damaged Ductwork

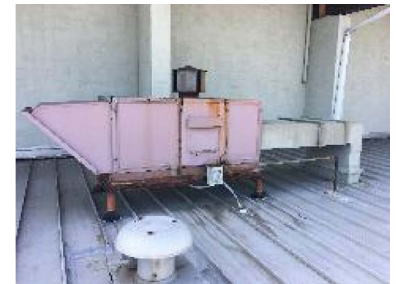
Exhaust Fans – There are four large exhaust fans on the gym roof that work in conjunction with the make-up air units for this space. They are either original to the building or were replaced with the roofing, which would make them 20+ years old. The heat only make-up air units were recently replaced, but the controls tying them to the exhaust fans do not appear to have been fully addressed at that time. It was recommended that other miscellaneous building exhaust fans could be easily replaced as necessary.

Society Bldg Make-Up-Air Unit

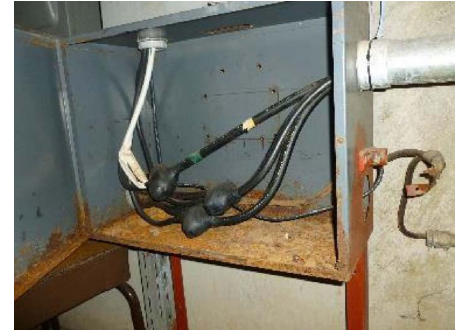
This report indicates that original panelboards and branch circuit wiring is still being used, and at 50-60 years old they have reached the end of their useful service life. Newer panels have been added over time to supplement original construction as more and more technology has been implemented throughout the building. While it is noted that the newer additional wiring is code compliant, much of it is exposed in the rooms and not very attractive. The most notable safety concern reported is the lack of ground fault protected (GFI) devices when located within 6' of classroom sinks and the kitchen. Lighting is inconsistent throughout the building and even within classrooms. Many light fixtures have different lamps even within the same fixtures as evidenced by the different colors. Inconsistencies between fixtures and lamps can decrease efficiency and should be optimized. The report suggested that consideration be given to changing the existing fluorescent lighting to more efficient LEDs with occupancy and possibly daylight sensors.

Primary Bldg Splice Box

Feeder cables, branch circuit wiring - All equipment more than 40 years old should be replaced. This includes all but the panelboards installed in the Upper Unit or added since the 1990s to supplement existing classrooms.

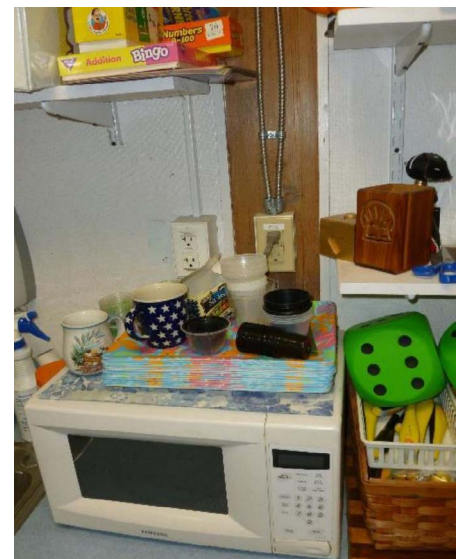
Exposed MC Cable to New Outlets

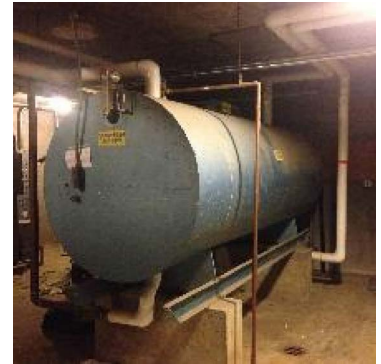
Society Bldg Hot Water Tank

Domestic Hot Water – The large hot water heater/tank in the Society Building Basement is over 50 years old. It has far exceeded its 20-year expected service life and should be replaced before failure. A multi-tank high efficiency gas fired system was recommended as an alternative for efficiency and ease of maintenance. It is also to be noted that locker room showers are not typically used by students any longer, so capacity is less than originally required. McHugh also recommended replacing system gate valves throughout that do not close completely with new ball valves.

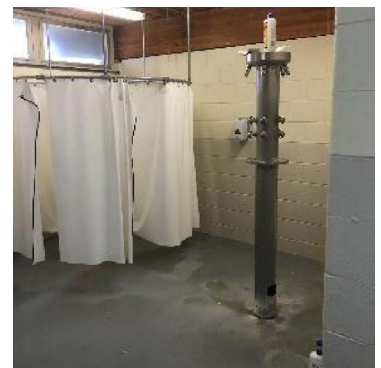
Locker Room Showers

Plumbing Fixtures – Consider replacement with new water efficient fixtures in any future renovation project.

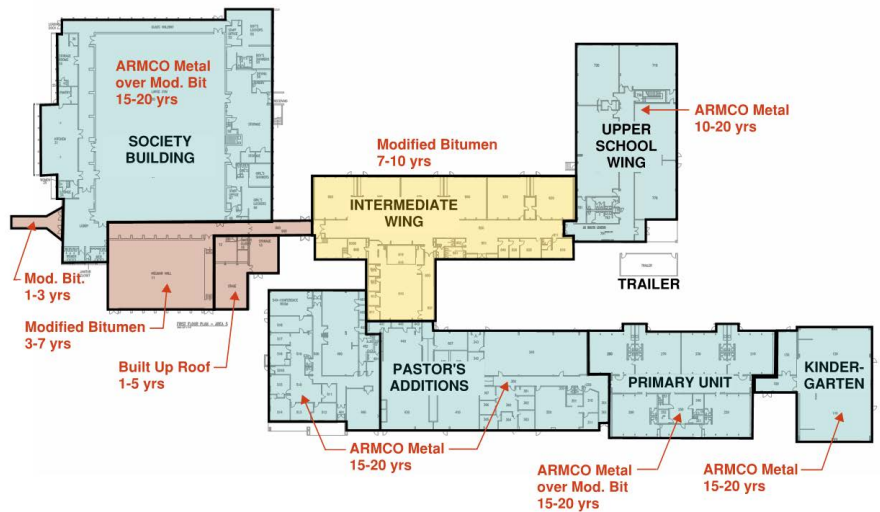
ARMCO metal roof systems - Areas of the building with this system include the Kindergarten, Primary Building, Library/Teacher's Lounge, Classroom Addition, Upper Unit, and portions of the Society Building and have the longest life left (approx. 15-20 years). This is good news; however, the report does caution that a when these roof do need repair, the work will require a structural engineer, since the metal system spans between structure and the entire walls and roof were designed as a single system. Modifications could require either a complete tear off of the existing panels (exposing the interior) or additional structural reinforcing.

Note: ARMCO Roofs will need Gutters and Downspouts in 5-10 yrs.

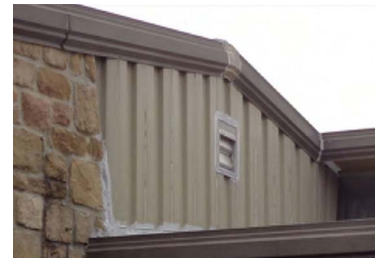
Sealant at Material Transitions

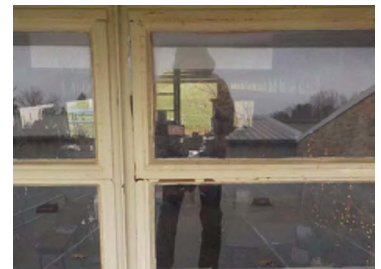
Replacements - The one commodity all these buildings have in common is the condition of the fenestration (windows and doors). Intertek notes that all windows and doors appear to have surpassed their useful lives and should be replaced. The most acute of the conditions are at the newer buildings that do not have deep overhangs. As part of the window and door replacements, the plate glass windows at the Society Building also need to be replaced and should be moved up near the top of the importance list. Their size and proximity to the floor represent a safety concern, and the single pane construction is very inefficient.

Primary Building Window Detail

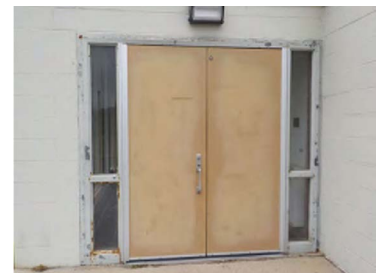
Society Bldg Door and Frame

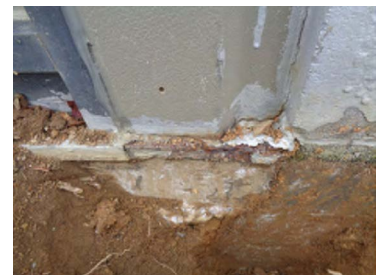
Metal Wall Panels at Grade

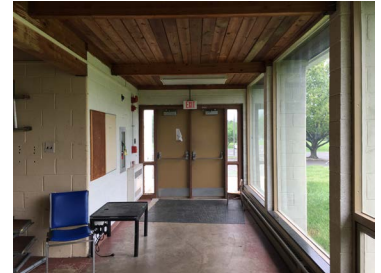
Society Bldg Corridor

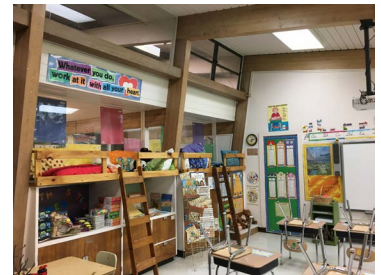
- Cabinetry – This is generally all original to the buildings, other than where storage in classrooms has been modified over time. In most locations, the casework has exceeded its useful life and is in poor condition. It should be replaced as spaces are renovated or in its entirety as part of a significant renovation.

Cabinetry - classroom lofts

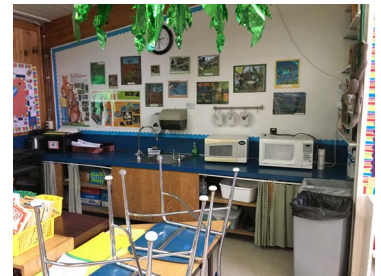
Cabinetry - classroom kitchens
